Manhole Inspection Summary

Manhole # S13CC2014MH

Location Address: **5709 CROSS COUNTRY BLVD**

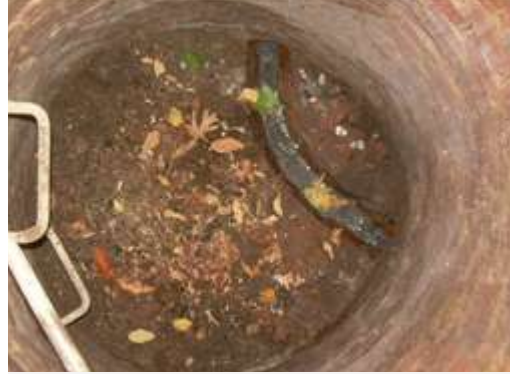
Top View

Bench debris.

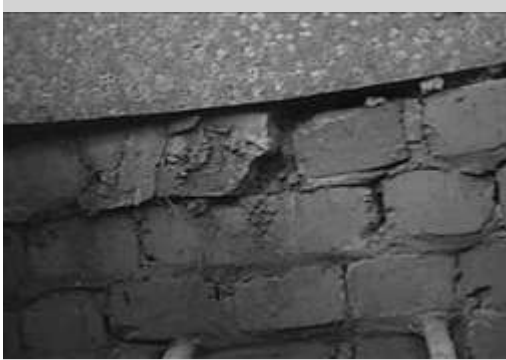
Defect

Condition: ☐ Sound ☐ Cracked ☒ **Root Intrusion** ☐ Loose Brick ☒ **Deteriorated**

Infiltration: ☐ None ☒ **Joint** ☐ Cracks ☐ Mortar ☒ **Roots** ☐ Wall

Adjustment deterioration and infiltration.

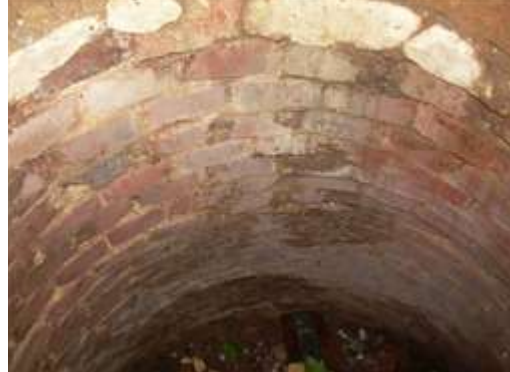
Defect

Infiltration: ☐ None ☐ Joint ☐ Cracks ☒ **Mortar** ☐ Roots ☒ **Wall**

Adjustment deterioration and infiltration.
Corbel and Barrel infiltration.

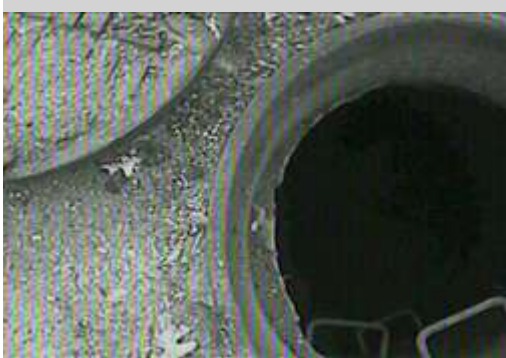
Defect

Frame Offset: **2** (in.) Condition: ☒ Sound ☐ Cracked ☐ Leaks

Frame offset.

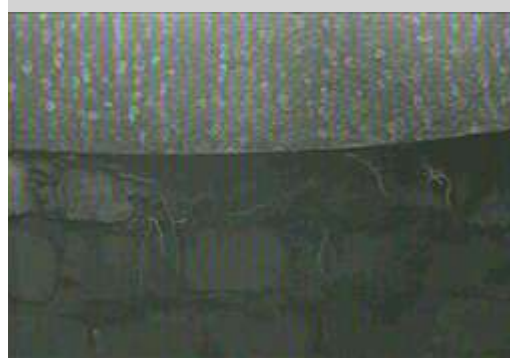
Defect

Adjustment deterioration, root intrusion
and infiltration.

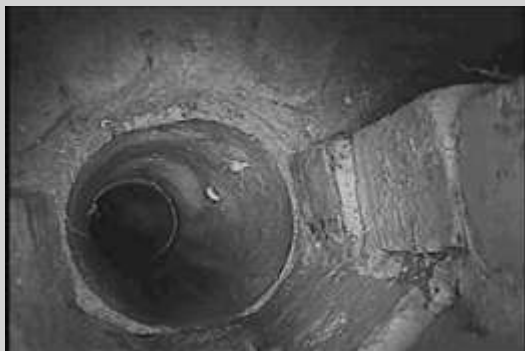
6 in. Circular Gravity Sewer Pipe In @ 3 O'Clock

Condition: ☐ Sound ☐ Cracked ☐ Root Intrusion ☒ **Deteriorated** ☐ Leaks ☐ Debris

Channel deterioration.

Infiltration: **Evidence** Pipe Seal Cond: **Roots**
